**Flood Control Project Maintenance
Levee Inspections**

Fall 2016 Levee Maintenance Deficiency Summary Report

Sacramento River Basin

| RD0150 | Overall LMA Rating | Total LMA Miles | * Overall LMA Threshold Percent is less than 10.00%; however, U Rated Miles are present, so the Overall LMA Rating is M instead of A. | | | | | |
|--|---|---|---|---|---|---|---|---|
| Reclamation District No. 0150 Merrit Island | M * | 17.74 | | | | | | |

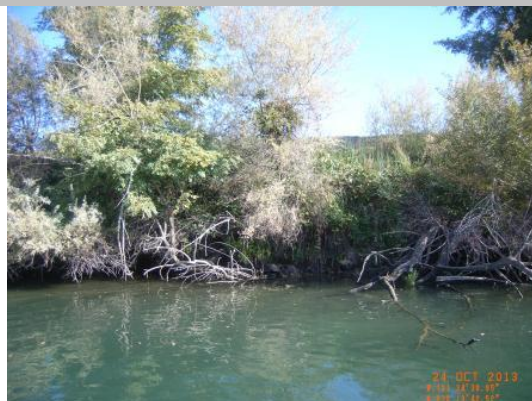
Photo 1 of 2 : FA_2016_RD0150_15_2_20160823_00001.jpg

| 2013 - Old toe repair unraveling. Bridge at upstream end of site. 2015: No observed changes. [2015 Site ID: STR_28-4_R] | | | | | |

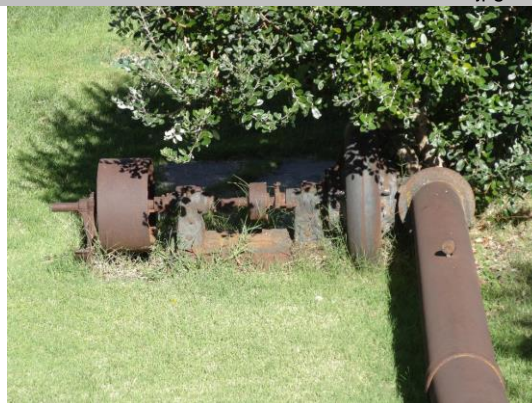
Photo 2 of 2 : UCIP_FA_2016_42700_34246.jpg

LS view: abandoned pipe and pump on landside toe.

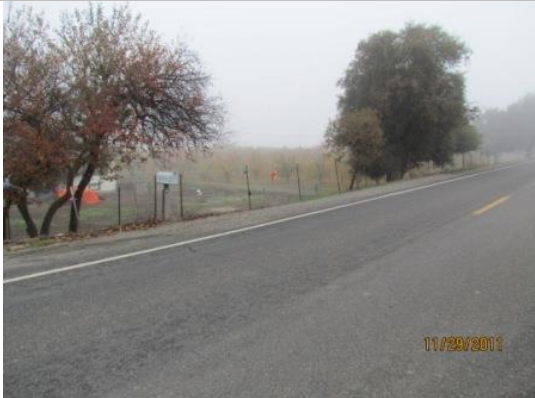
Photo 1 of 1 : FA_2016_RD0150_16_9_20160823_00006.jpg

Fence was found on the landside of the levee looking upstream.

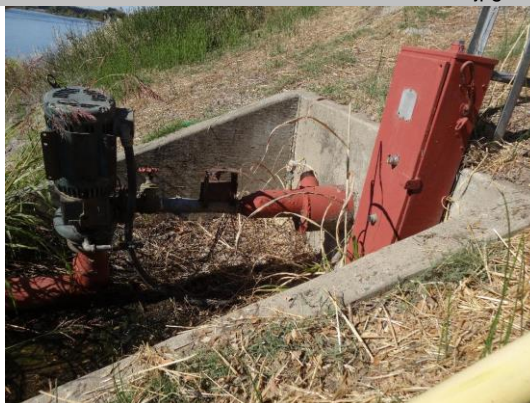
Photo 2 of 2 : UCIP_FA_2016_20268_34243.jpg

| UCIP Comments: - Water leaks from pressure breaker.- Distribution box at the landward toe not found/visible.- Service pole on LS toe. | | | | | |

WS view: pump, electric control box, electric conduit on concrete pad.
Water leaks from pressure breaker.

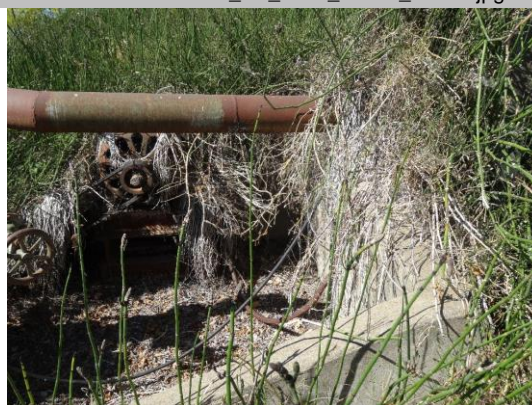
Photo 2 of 2 : UCIP_FA_2016_20267_34238.jpg

WS view: steel pipe and pump on concrete pad. Seems abandoned.

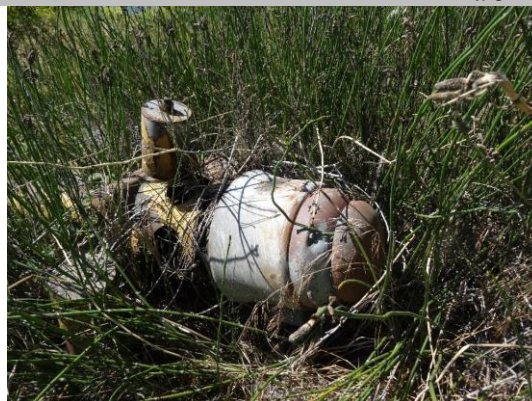
Photo 1 of 2 : UCIP_FA_2016_20284_34265.jpg

| FS_ID:20284 DS_ID:22419 EP_NO: N/A Repair Type: Non-Urgent Crossing Status: Found UCIP Comments: Needs proper abandonment. FIELD_STRUCT_DESC: 8-inch steel pipe through the levee, 5.7 feet below the crown. Power line on landside.(Mrs. J. Olson) O&M Manual SAC 112, March 1957. FS Date: 8/27/2013 | | | | | |

WS view: abandoned pump on levee slope. Dense vegetation on waterside.

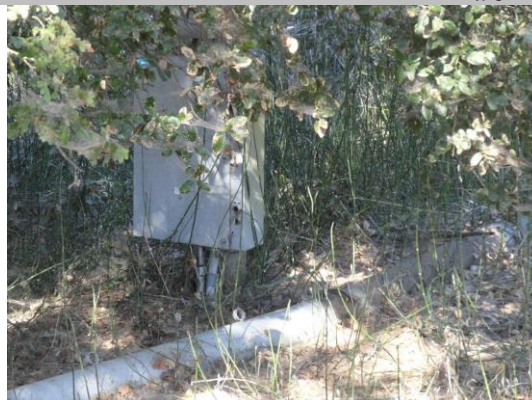
Photo 2 of 2 : UCIP_FA_2016_20284_34264.jpg

LS view: exposed steel pipe and power pole on levee toe.

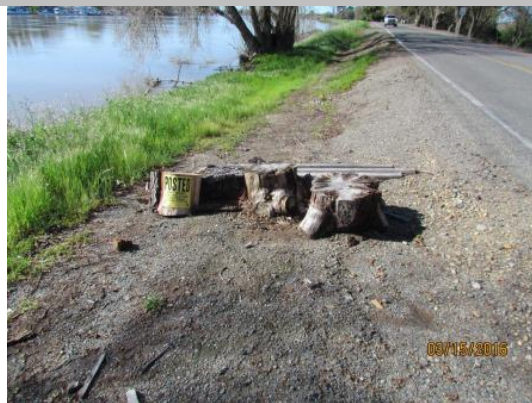
Photo 1 of 1 : FA_2016_RD0150_16_57_20160823_00032.jpg

View of tree stumps on the waterside shoulder of the levee looking downstream.

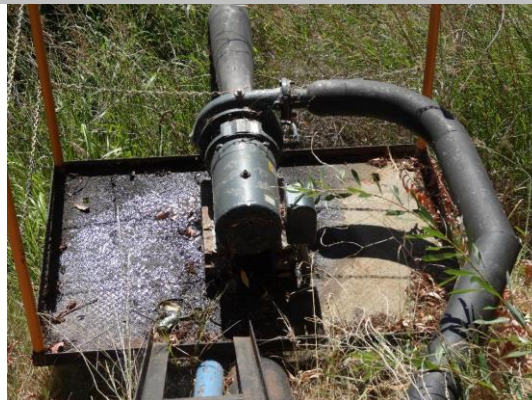
Photo 2 of 2 : UCIP_FA_2016_20303_34286.jpg

FS_ID:20303
DS_ID:22421
EP_NO: 16109
Repair Type: Non-Urgent
Crossing Status: Found
UCIP Comments: - 10" steel pipe on both sides of the levee. According to permit and inspectors note- 16" steel pipe through the levee.- concrete standpipe inside water filtration plant on landside toe.- air pressure tank on waterside steel deck.
FIELD_STRUCT_DESC: 16 inch steel pipe and 2-inch conduit through the levee, 6.2 feet below the crown, slant pump on steel platform on the waterward slope. 4-inch abandoned pipe on the waterside slope. Concrete stand pipe and power pole at landside toe. (App. No. 18258, Wilson 2007) O&M Manual SAC 112, March 1957.
FS Date: 8/27/2013

WS view: steel pipes and leaky slant pump on steel deck.

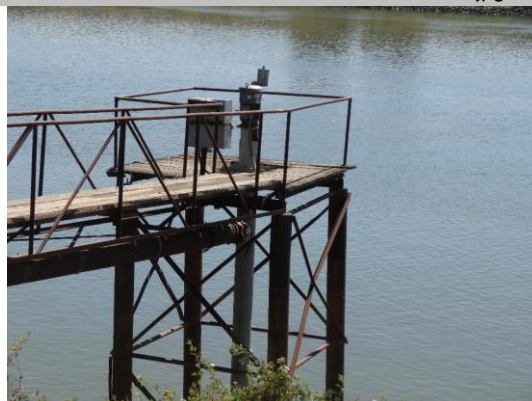
Photo 2 of 2 : UCIP_FA_2016_20348_34370.jpg

WS view: pipe & pump on piling structure in the stream.

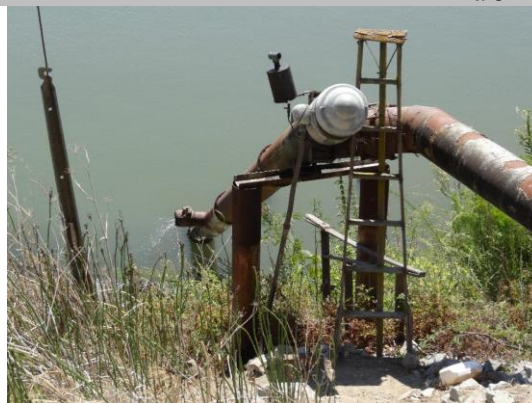
Photo 1 of 2 : UCIP_FA_2016_20731_34902.jpg

| UCIP Comments: - Operating during inspection. Leaky join at the concrete box.- Power overhead crossing. Power pole at waterside shoulder, and landside toe. | | | | | |

WS view: slant pump on steel frame support and exposed pipe on levee slope.

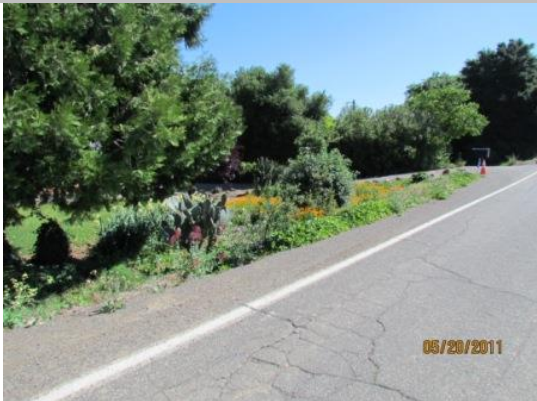
Photo 1 of 1 : FA_2016_RD0150_16_88_20160823_00046.jpg

Landscaping was found on the landside of the levee. The picture was taken from the crown looking upstream.

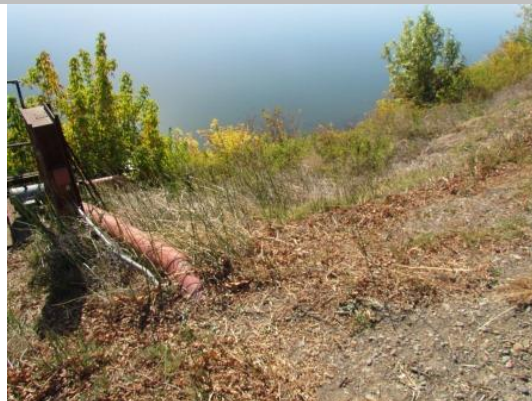
Photo 2 of 5 : FA_2016_RD0150_16_961_20160823_00051.jpg

| Depressions into the waterward slope can be seen along the waterward slope at this site. Also note the damaged pump support, pump, and pipe just upstream of the site; they may contribute to the erosion in a high water event and should be removed. | | | | | |

View of the erosion on the waterside slope of the levee near the pipe looking downstream. This picture was taken during the fall 2013 inspection.

| E2 : Schedule repair of erosion site prior to the next inspection. | | | | | |

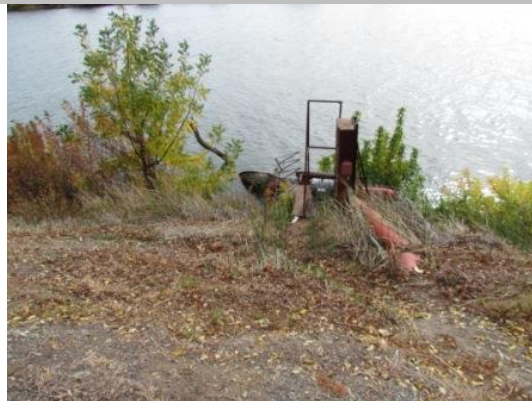
Photo 4 of 5 : FA_2016_RD0150_16_961_20160823_00053.jpg

| Depressions into the waterward slope can be seen along the waterward slope at this site. Also note the damaged pump support, pump, and pipe just upstream of the site; they may contribute to the erosion in a high water event and should be removed. | | | | | | |

View of erosion and damaged pipe and abandoned boat on the waterside of the levee looking upstream. This picture was taken during fall 2012 inspection.

| E2 : Schedule repair of erosion site prior to the next inspection. | | | | | | |

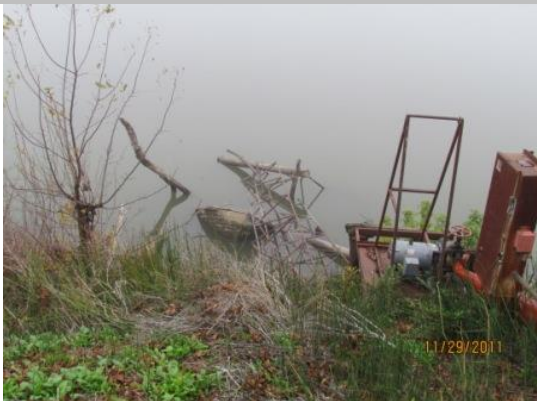
Photo 5 of 5 : FA_2016_RD0150_16_961_20160823_00054.jpg

View of the erosion site, and broken pump support along with a boat on the waterside of the levee. The picture was taken from the crown looking towards the toe of the levee during fall 2011 inspection.

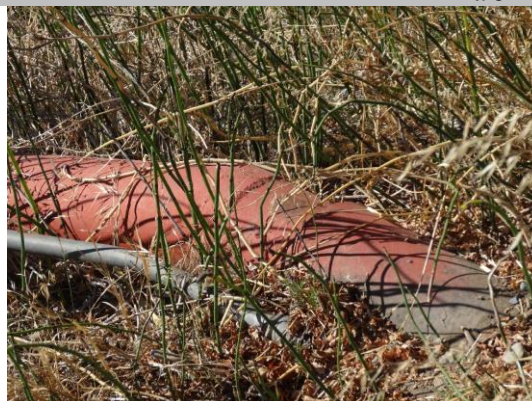
Photo 2 of 2 : UCIP_FA_2016_20736_34916.jpg

| FS_ID:20736 DS_ID:22402 EP_NO: N/A Repair Type: Non-Urgent Crossing Status: Found UCIP Comments: - 10" steel pipe sleeved through 12" steel pipe.- main pipe bifurcates into two pipes on LS slope and connected to standpipe and concrete box.- 2" electric conduit on WS and power pole on LS.- needs filling into gap between 10" and 12" steel pipes on LS. FIELD_STRUCT_DESC: 12-inch steel pipe through the levee, 4.0 feet below the crown; pump on piling in stream. Concrete standpipe and concrete distribution box at the toe of the landward slope. (A. Green) O&M Manual SAC 112, March 1957. FS Date: 8/30/2013 | | | | | |

WS view: steel pipe and GI conduit on levee slope.

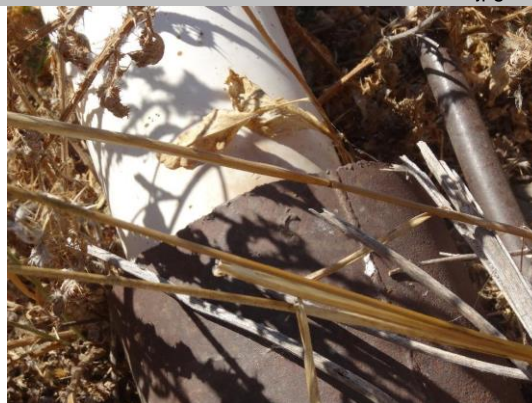
Photo 2 of 2 : UCIP_FA_2016_19846_33726.jpg

WS view: steel conduit (right); 8" pvc pipe sleeved into 12" steel pipe.

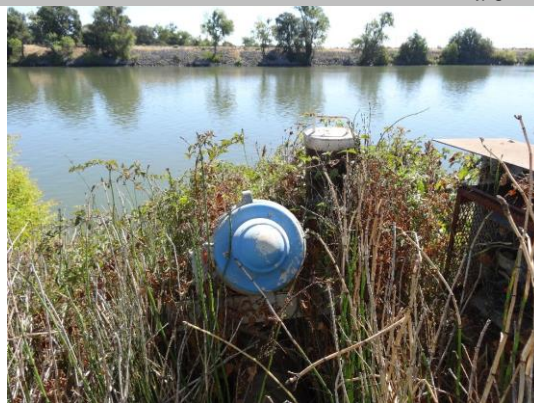
Photo 1 of 2 : UCIP_FA_2016_42702_33782.jpg

WS view: slanted pump on levee slope.

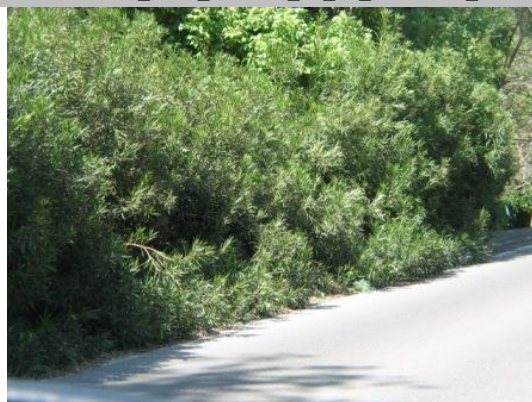
Photo 1 of 1 : FA_2016_RD0150_16_24_20160823_00015.jpg

Landscaping (Oleander) on landward slope from 4.33 to 4.35

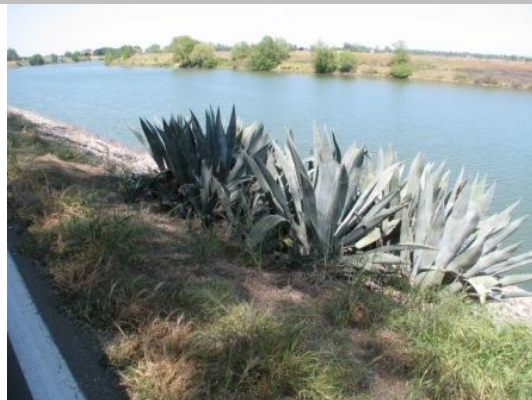
Photo 1 of 1 : FA_2016_RD0150_16_28_20160823_00017.jpg

Century plant on waterward slope at LM 4.76

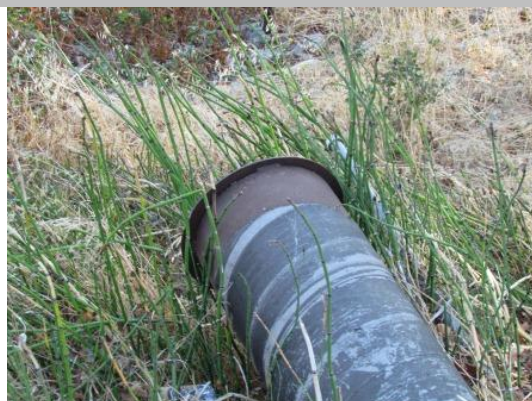
Photo 1 of 1 : FA_2016_RD0150_16_69_20160823_00039.jpg

The pipe cover doesn't appear to be water tight on the waterside slope of the levee. The picture was taken from the crown looking towards the toe of the levee during fall 2013 inspection.

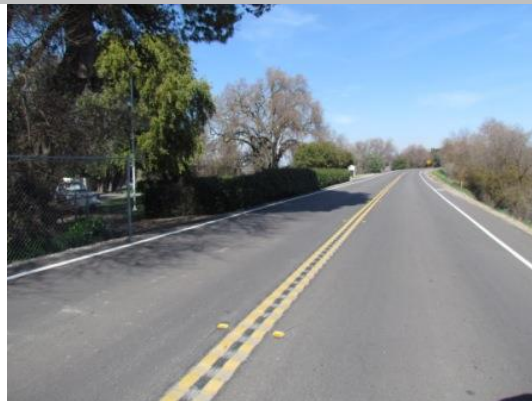
Photo 1 of 1 : FA_2016_RD0150_16_30_20160823_00018.jpg

Landscaping was found on the landside shoulder of the levee looking upstream.

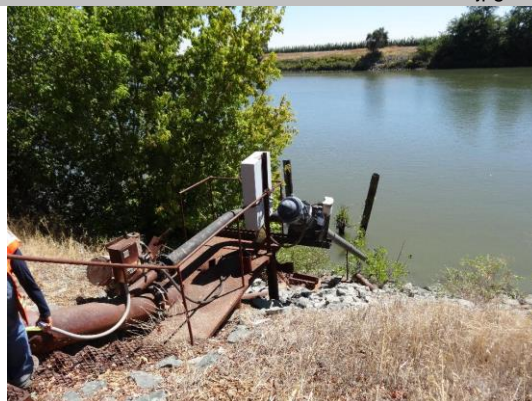
Photo 1 of 2 : UCIP_FA_2016_20740_34941.jpg

WS view: pipe, walkway, slant pump & pump platform on stream bank.

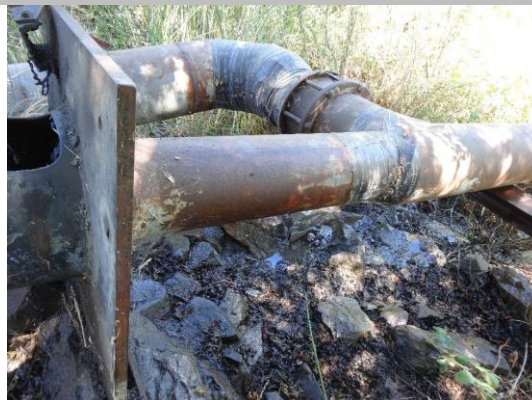
Photo 2 of 2 : UCIP_FA_2016_20748_34966.jpg

WS view: leaky steel pipe and slant pump on levee slope.

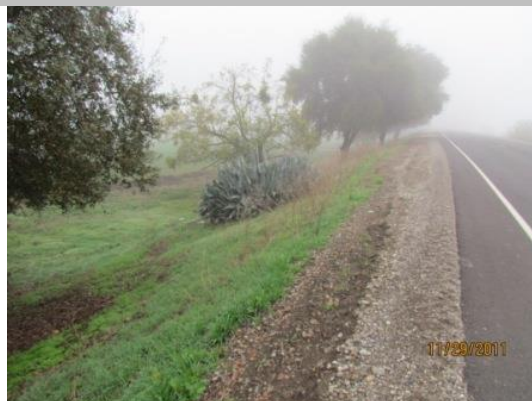
Photo 1 of 1 : FA_2016_RD0150_16_27_20160823_00016.jpg

Century plant was found on the landside of the levee looking upstream.

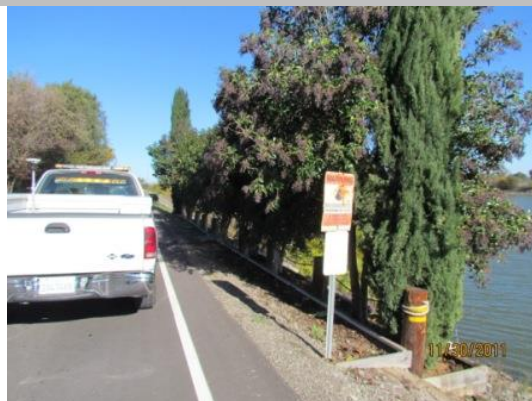
Photo 1 of 1 : FA_2016_RD0150_16_34_20160823_00021.jpg

Landscaping was found on the waterside of the levee looking upstream.

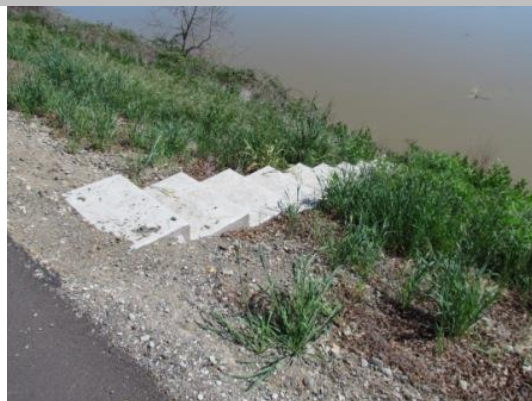
Photo 1 of 1 : FA_2016_RD0150_16_42_20160823_00023.jpg

A stairway was found on the waterside slope of the levee looking upstream.

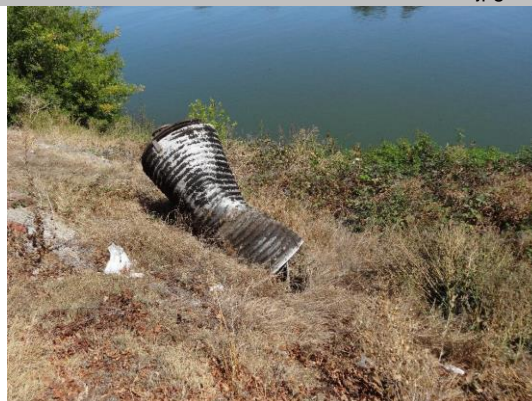
Photo 1 of 2 : UCIP_FA_2016_50669_34985.jpg

WS view: an abandoned and dismantled CMP riser on WS levee slope.

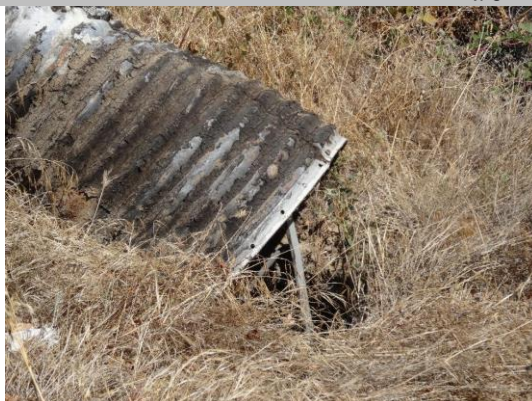
Photo 2 of 2 : UCIP_FA_2016_50669_34984.jpg

WS view: closer view of an abandoned and dismantled CMP riser on WS levee slope.

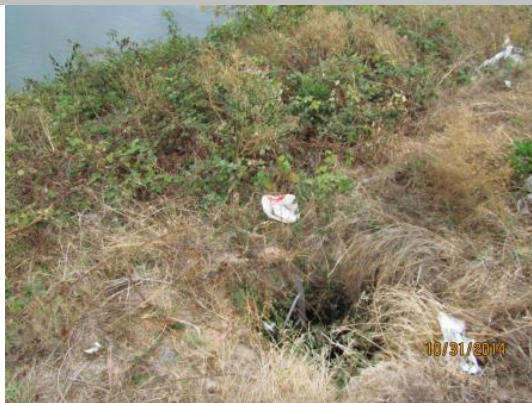
Photo 1 of 1 : FA_2016_RD0150_16_55_20160823_00030.jpg

An open pipe valve was found without a cover on the waterside toe of the levee.

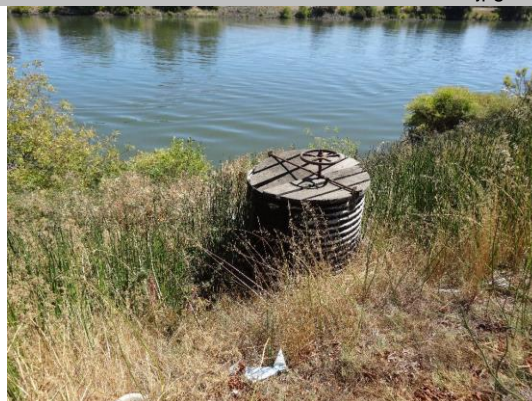
Photo 1 of 2 : UCIP_FA_2016_41720_34081.jpg

WS view: CMP riser with gate valve on levee slope. Dense vegetation on levee slope and stream bank.

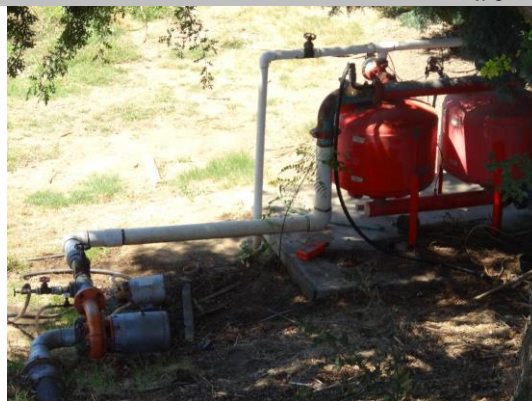
Photo 2 of 2 : UCIP_FA_2016_41720_34080.jpg

LS view: concrete vault, pipe, and pump in water filtration plant.

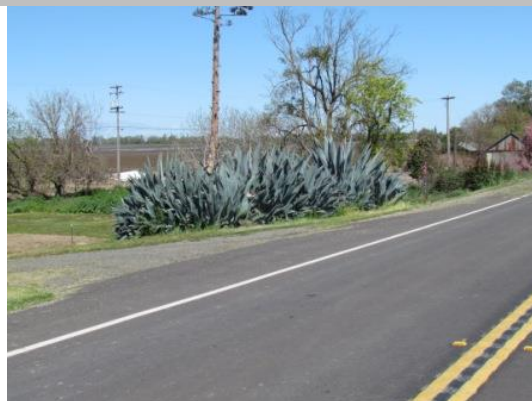
Photo 1 of 1 : FA_2016_RD0150_16_43_20160823_00024.jpg

Century plants were found on the landside of the levee looking upstream.

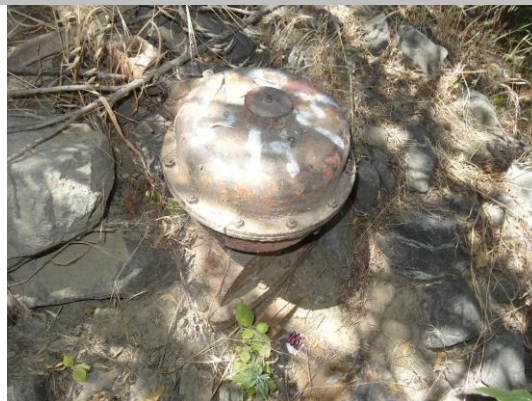
Photo 2 of 2 : UCIP_FA_2016_41646_34101.jpg

WS view: An abandoned old gate valve on inlet steel pipe on stream bank.

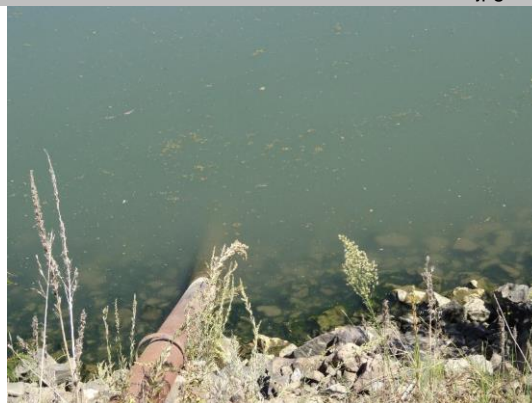
Photo 2 of 2 : UCIP_FA_2016_50387_35001.jpg

WS view: steel inlet pipe in the stream and bank.

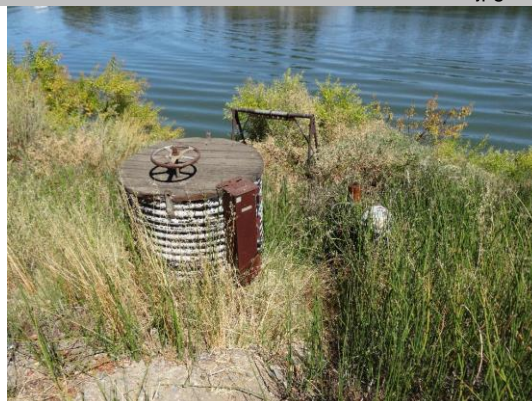
Photo 1 of 2 : UCIP_FA_2016_50386_34162.jpg

WS view: CMP riser with slide gate and pump (right) on levee slope.

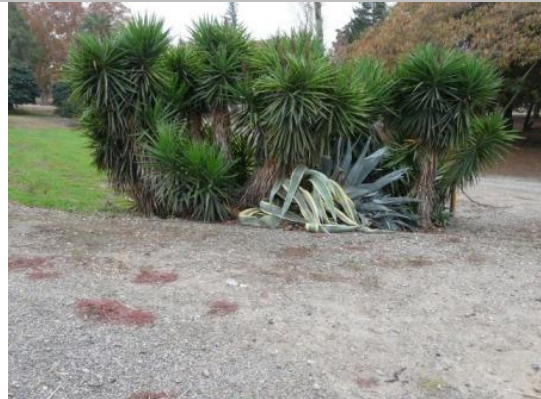
Photo 1 of 1 : FA_2016_RD0150_16_56_20160823_00031.jpg

Landscaping on landside of levee at LM 7.92

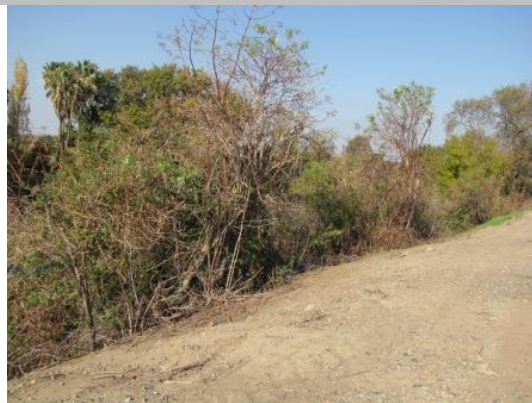
Photo 1 of 1 : FA_2016_RD0150_17_936_20160823_00101.jpg

View of elderberry bush within 20 feet of shoulder blocking visibility and access.

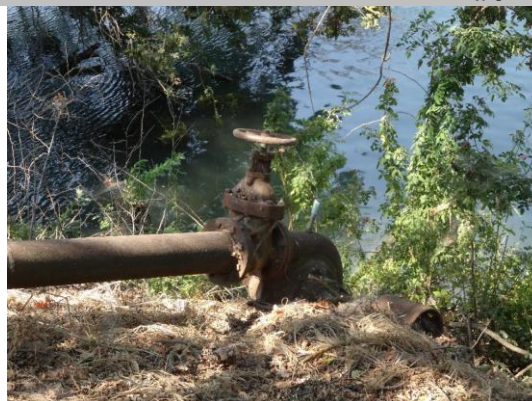
Photo 1 of 2 : UCIP_FA_2016_42694_32005.jpg

WS view: pipe and pump on levee slope.

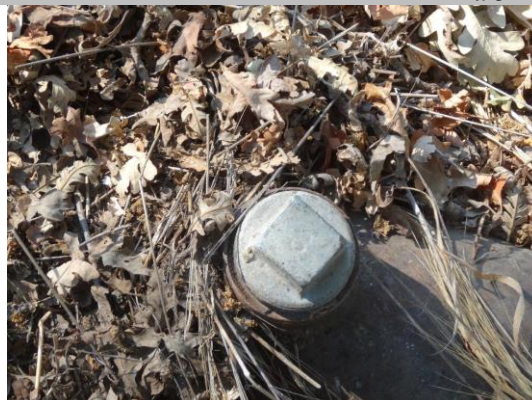
Photo 2 of 2 : UCIP_FA_2016_42694_32004.jpg

WS view: safety valve on steel pipe.

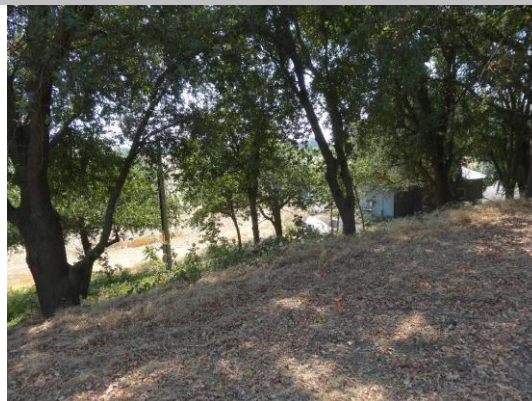
Photo 2 of 2 : UCIP_FA_2016_42693_31978.jpg

LS view: no pipe on levee slope.

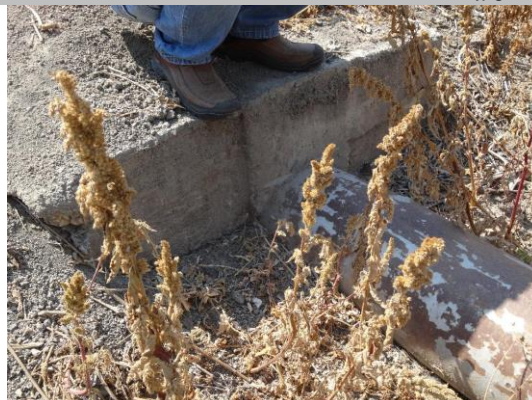
Photo 2 of 2 : UCIP_FA_2016_19112_32043.jpg

WS view: concrete headwall and exposed pipe on levee slope.

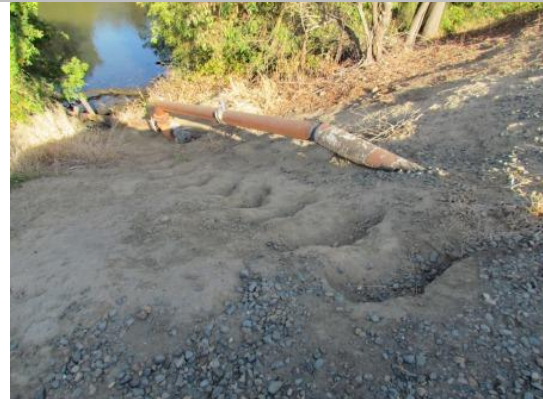
Photo 1 of 1 : FA_2016_RD0150_17_50_20160823_00041.jpg

Steps were dug next to the pipe and also erosion was found near the vicinity of the pipe on the waterside slope of the levee looking upstream.

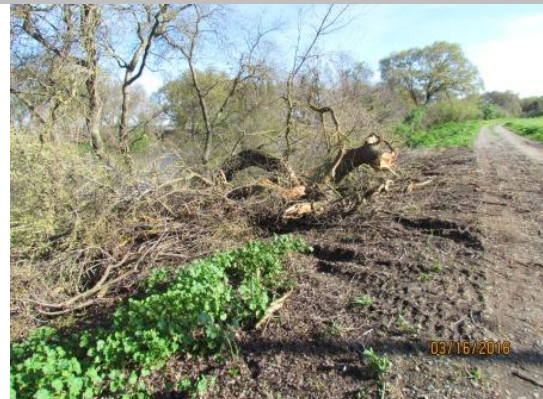
Photo 1 of 1 : FA_2016_RD0150_17_85_20160823_00078.jpg

View of broken tree trunk on the waterside slope of the levee.

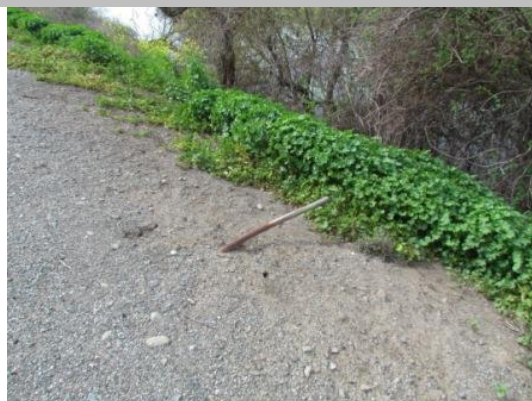
Photo 1 of 1 : FA_2016_RD0150_17_34_20160823_00027.jpg

A pipe was found on the waterside shoulder of the levee looking downstream during spring 2013 inspection.

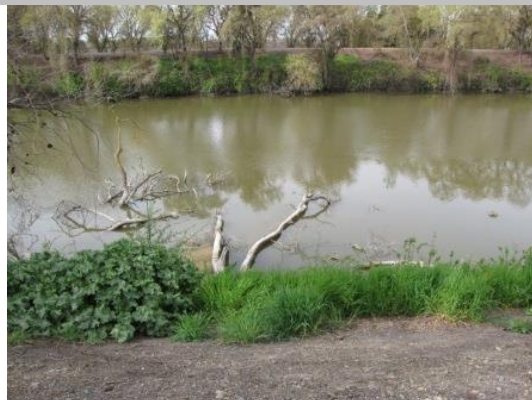
Photo 1 of 1 : FA_2016_RD0150_17_17_20160823_00015.jpg

View of tree stumps on the waterward slope.

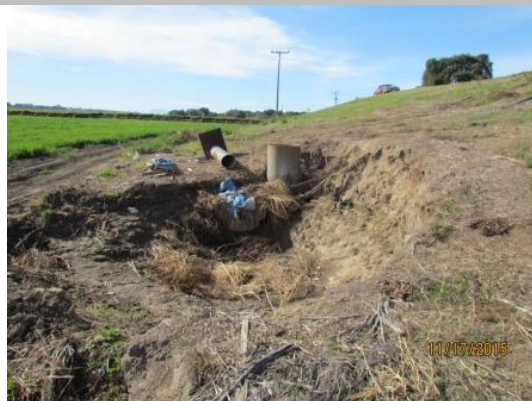
Photo 2 of 3 : FA_2016_RD0150_17_115_20160823_00093.jpg

Updated picture of the ditch on the landside toe of the levee during fall 2015 inspection.

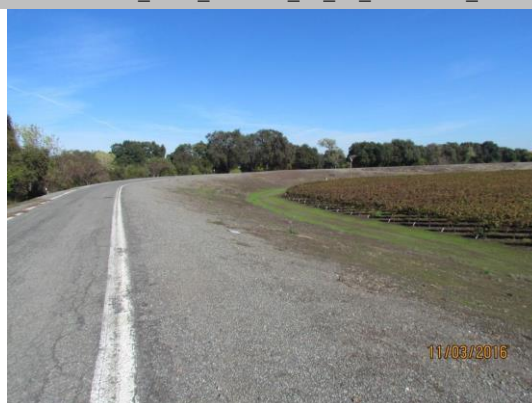
Photo 1 of 1 : FA_2016_RD0150_17_71_20161104_00146.jpg

View of the landside of the levee looking upstream. Fall 2016

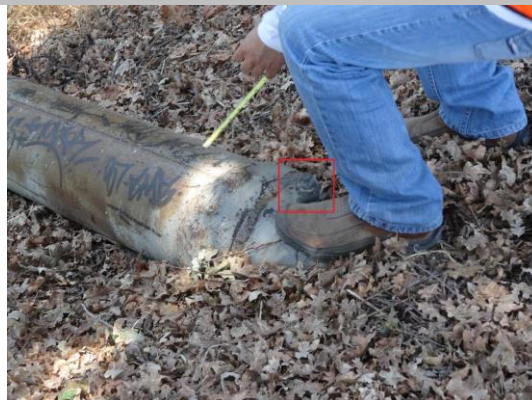
Photo 2 of 2 : UCIP_FA_2016_50202_35021.jpg

WS view: steel pipe with safety valve (marked) on levee slope.

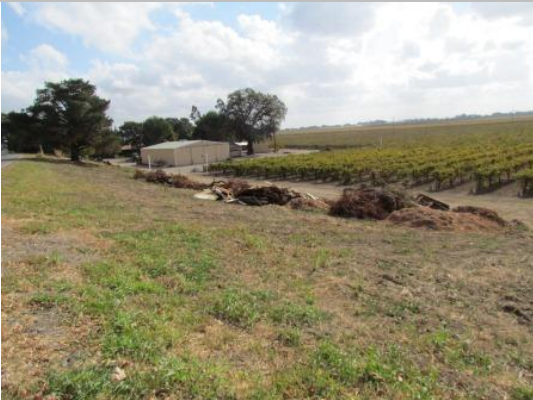
Photo 1 of 1 : FA_2016_RD0150_17_51_20160823_00045.jpg

Updated picture of the pruning pile on the landside of the levee looking

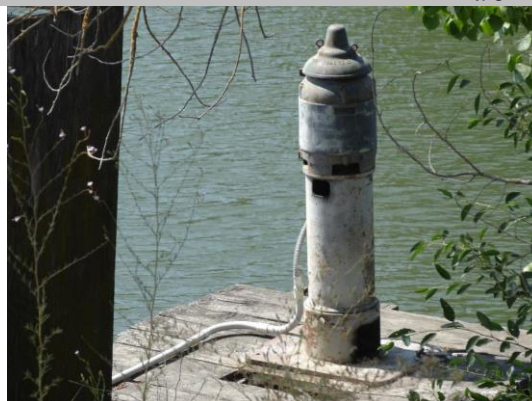
Photo 1 of 2 : UCIP_FA_2016_19281_32541.jpg

WS view: vertical pump on deck.

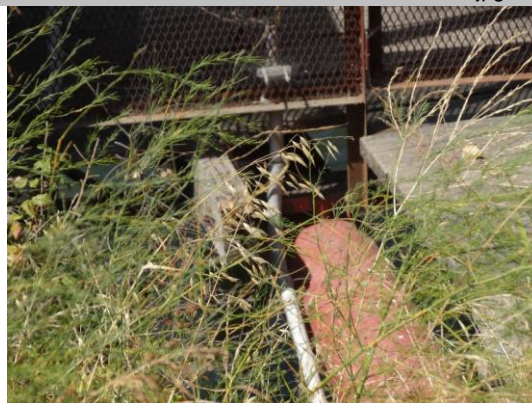
Photo 2 of 2 : UCIP_FA_2016_19281_32540.jpg

WS view: 1-inch GI conduit (left) and steel pipe (right)

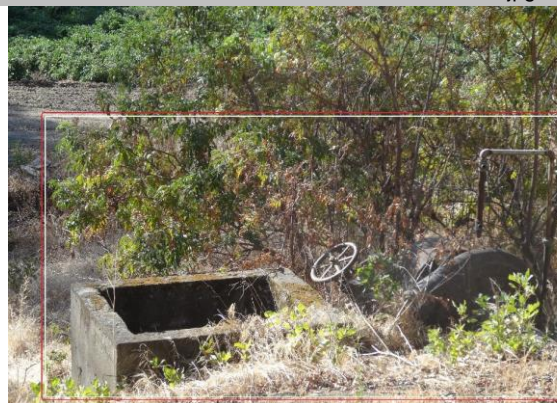
Photo 2 of 2 : UCIP_FA_2016_19283_32564.jpg

LS view: abandoned pump set and concrete box on levee slope.

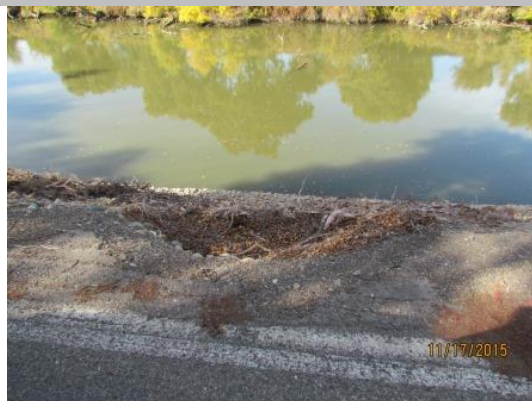
Photo 1 of 2 : FA_2016_RD0150_17_36_20160823_00030.jpg

Updated picture of the slope instability of the waterside shoulder of the levee during fall 2015 inspection.

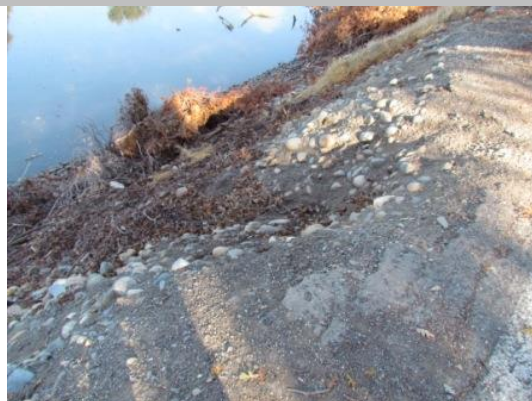
Photo 2 of 2 : FA_2016_RD0150_17_36_20160823_00031.jpg

Slope instability was found on the waterside of the levee looking upstream.

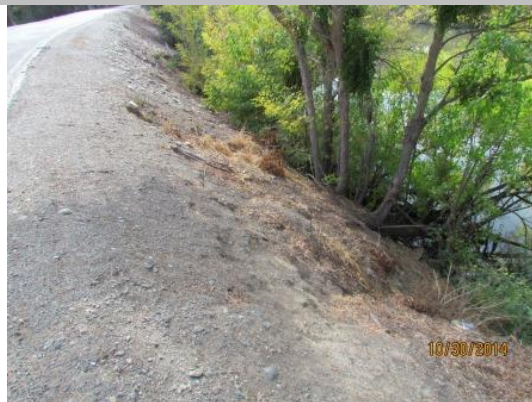
Photo 1 of 1 : FA_2016_RD0150_17_81_20160823_00074.jpg

View of erosion on the waterside of the levee looking downstream.

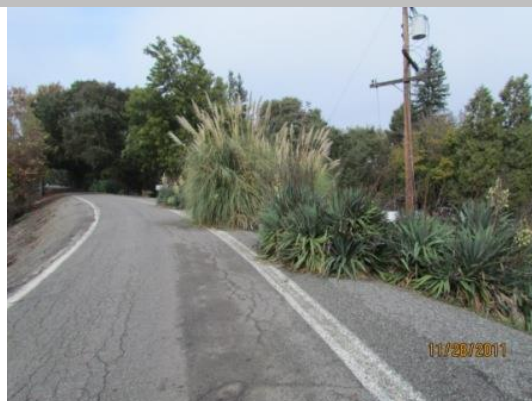
Photo 1 of 1 : FA_2016_RD0150_17_21_20160823_00017.jpg

Landscaping was found on the landside of the levee looking upstream.

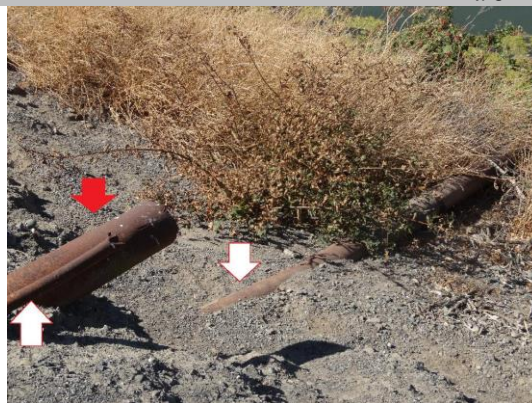
Photo 1 of 2 : UCIP_FA_2016_19403_32942.jpg

WS view: open ended 6" steel pipe (top-left), 1" steel pipe (bottom), and another 6" steel pipe (right) on levee slope.

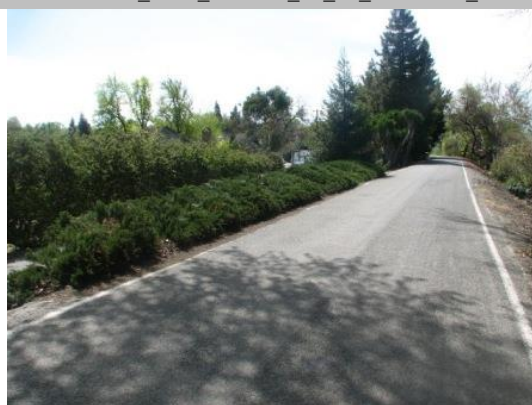
Photo 1 of 1 : FA_2016_RD0150_17_26_20160823_00019.jpg

Landscaping on landward slope.

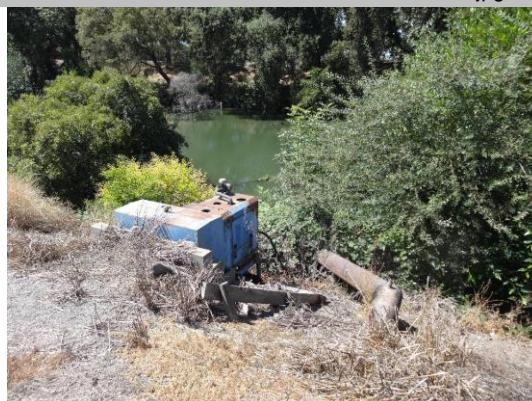
Photo 1 of 2 : UCIP_FA_2016_42692_35082.jpg

WS view: steel pipe (right) and diesel pump on levee slope.

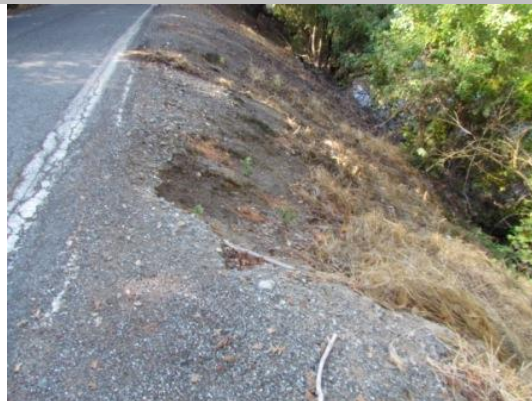
Photo 2 of 2 : FA_2016_RD0150_17_61_20160823_00055.jpg

Erosion was found on the waterside slope of the levee looking downstream. This updated picture was taken during fall 2012 inspection.

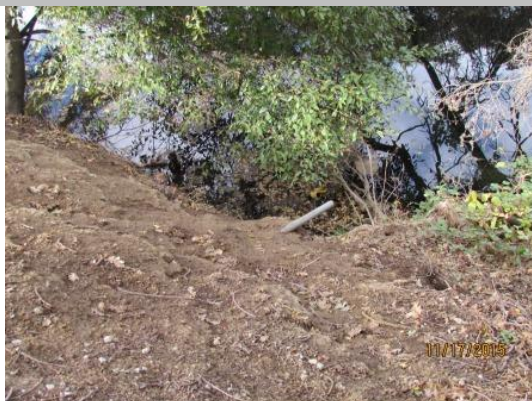
Photo 1 of 1 : FA_2016_RD0150_17_53_20160823_00047.jpg

View of a pipe on the waterside of the levee.

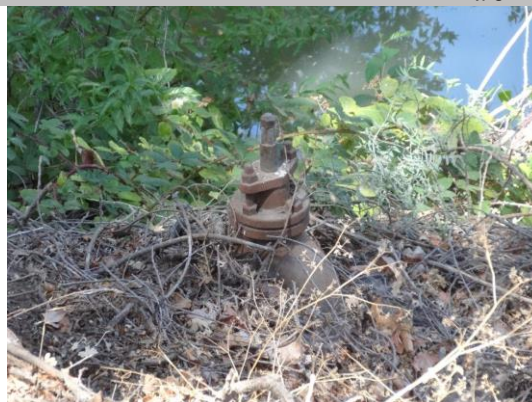
Photo 2 of 2 : UCIP_FA_2016_50670_33626.jpg

WS view: abandoned gate valve found on levee slope.

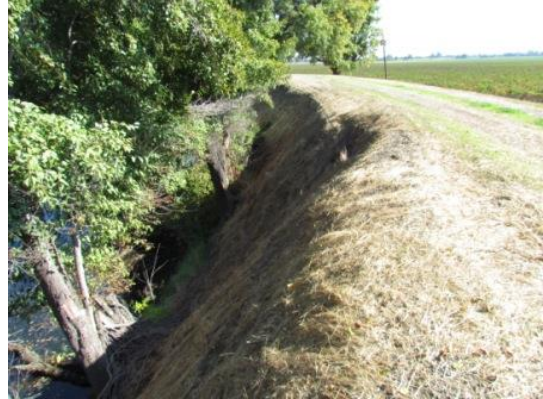
Photo 2 of 2 : FA_2016_RD0150_17_67_20160823_00063.jpg

Erosion was found on the waterside shoulder of the levee looking upstream. This picture was taken during fall 2012 inspection.

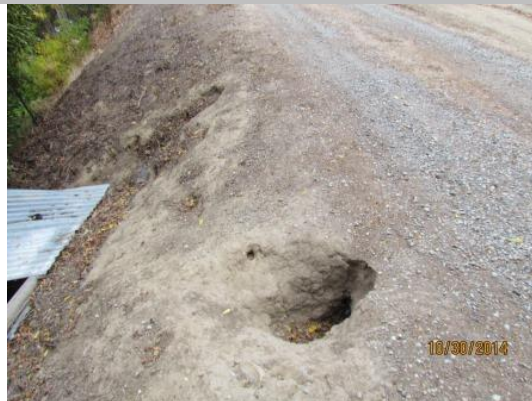
Photo 2 of 2 : FA_2016_RD0150_17_89_20160823_00082.jpg

Updated picture of a rodent hole on the waterside shoulder of the levee during fall 2014 inspection.

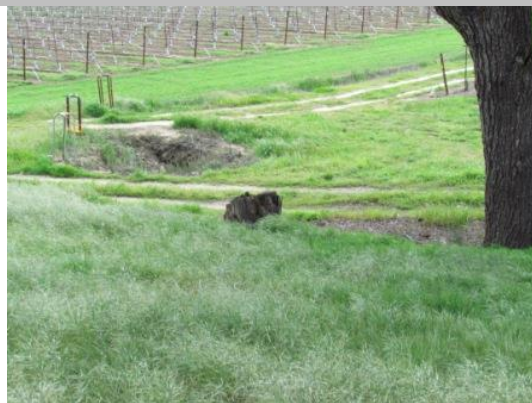
Photo 1 of 1 : FA_2016_RD0150_17_90_20160823_00083.jpg

A tree stump was found on the landside of the levee looking upstream.

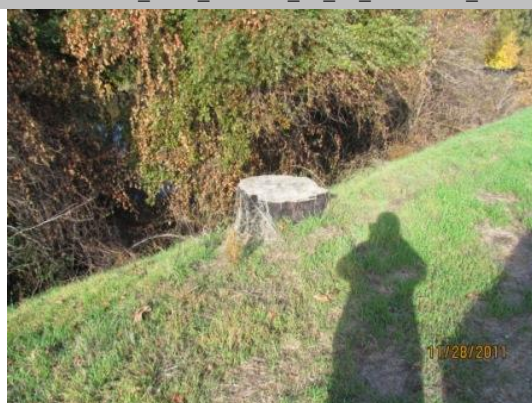
Photo 1 of 1 : FA_2016_RD0150_17_55_20160823_00048.jpg

A tree stump was found on the waterside of the levee looking upstream.

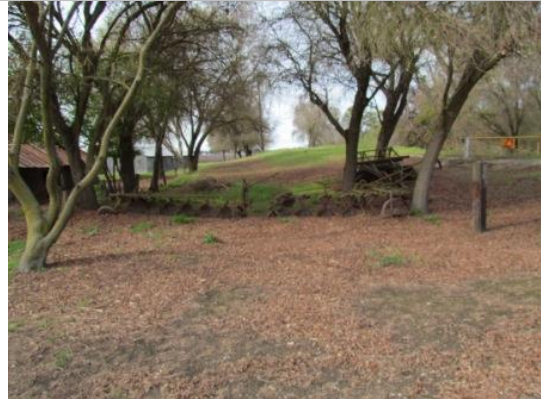
Photo 1 of 1 : FA_2016_RD0150_17_950_20160823_00103.jpg

Equipment was found on the landside of the levee looking downstream.
